# DEVELOPMENT OF HELICOPTER TRANSMISSION SEALS

## TASK II

**Sikorsky Aircraft**

1. Report No. NASA CR 120983	2. Government Accession No.	3. Recipient's Catalog No.	
4. Title and Subtitle Development of Helicopter Transmission Seals, Final Report Task II		5. Report Date July 1973

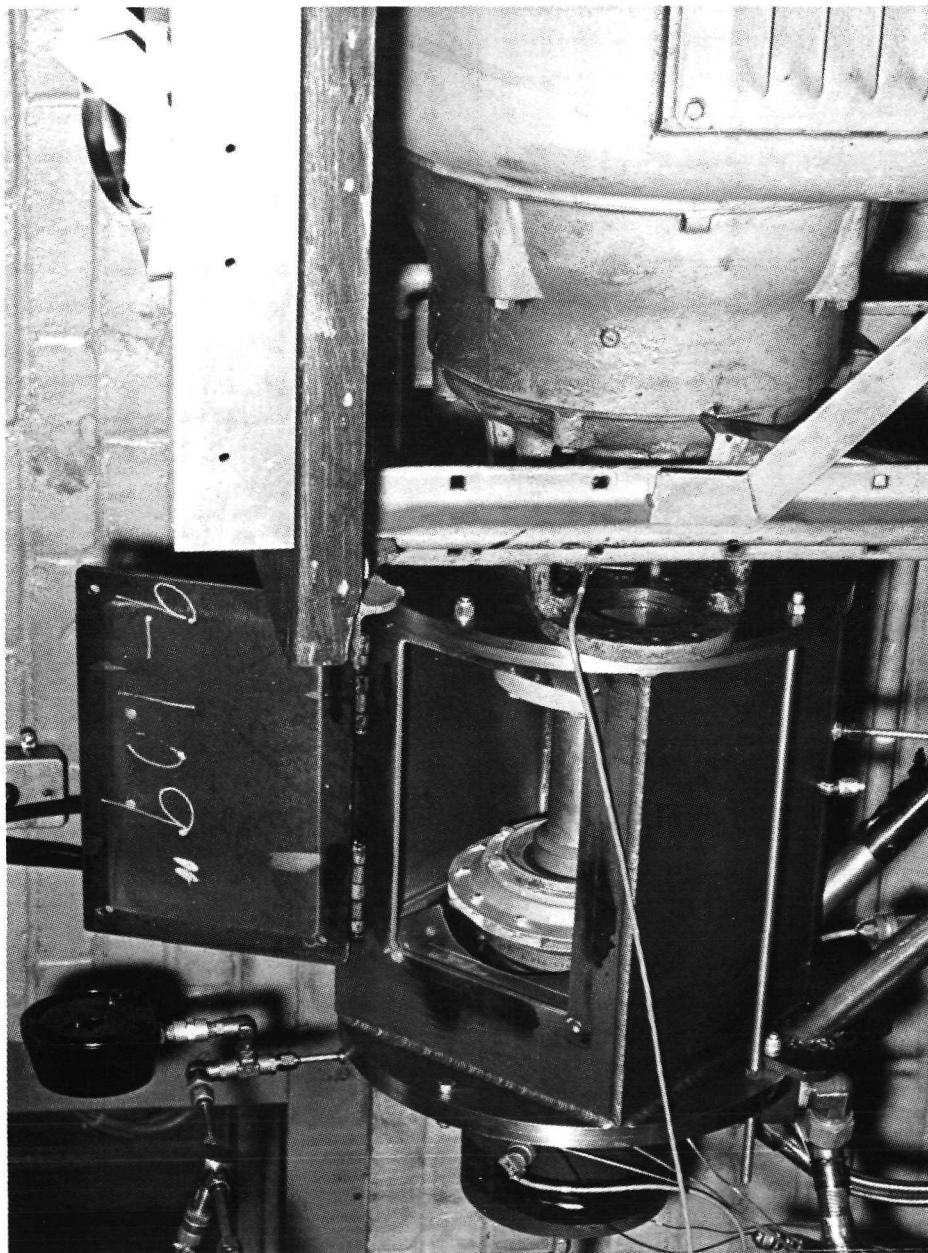
Figure 25. Seal Test Rig.

The test rig is shown in Figure 25.

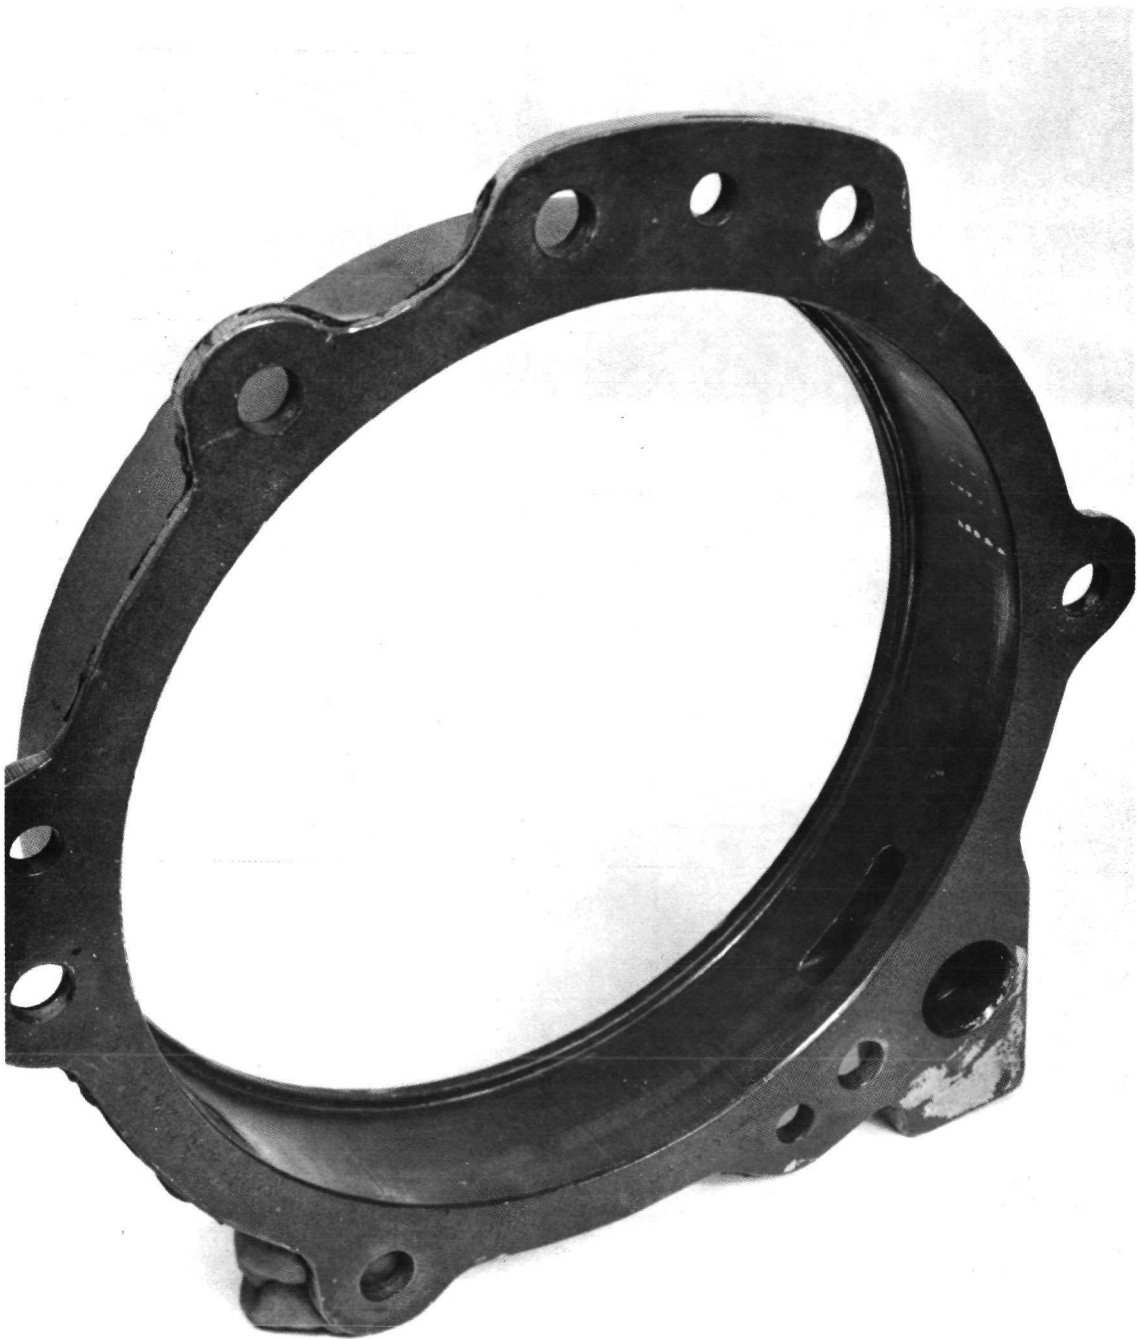
Figure 26. Housing Drain Location.

From results of the first screening test, it was evident that there was insufficient drainage for successful operation of the dual element split ring seal. As shown in Figure 26, the lowest point of the oil drain is at an angle of .582 radians (33.4 degrees) to the vertical and an oil head of approximately 13.45 m.m. (.53 inches) must be established before any drainage will occur. Locating the drain in this position is typical of helicopter transmission seal applications and is done to insure lubrication for lip seals. With the drain in this position, oil will at least cover the lower portion of the ring seal, as shown in Figure 27. The actual quantity of lubricant in the seal area in terms of lubricant in swirling motion and actual head height was not determined.

As shown in Table 3, the flooded seal ran .3 hours with a total leakage of 403 c.c. After disassembly the seal was inspected and found to be in excellent condition. The rings exhibited no wear or signs of heat discoloration. The cause of the high leakage rate was attributed to the drainage problem.

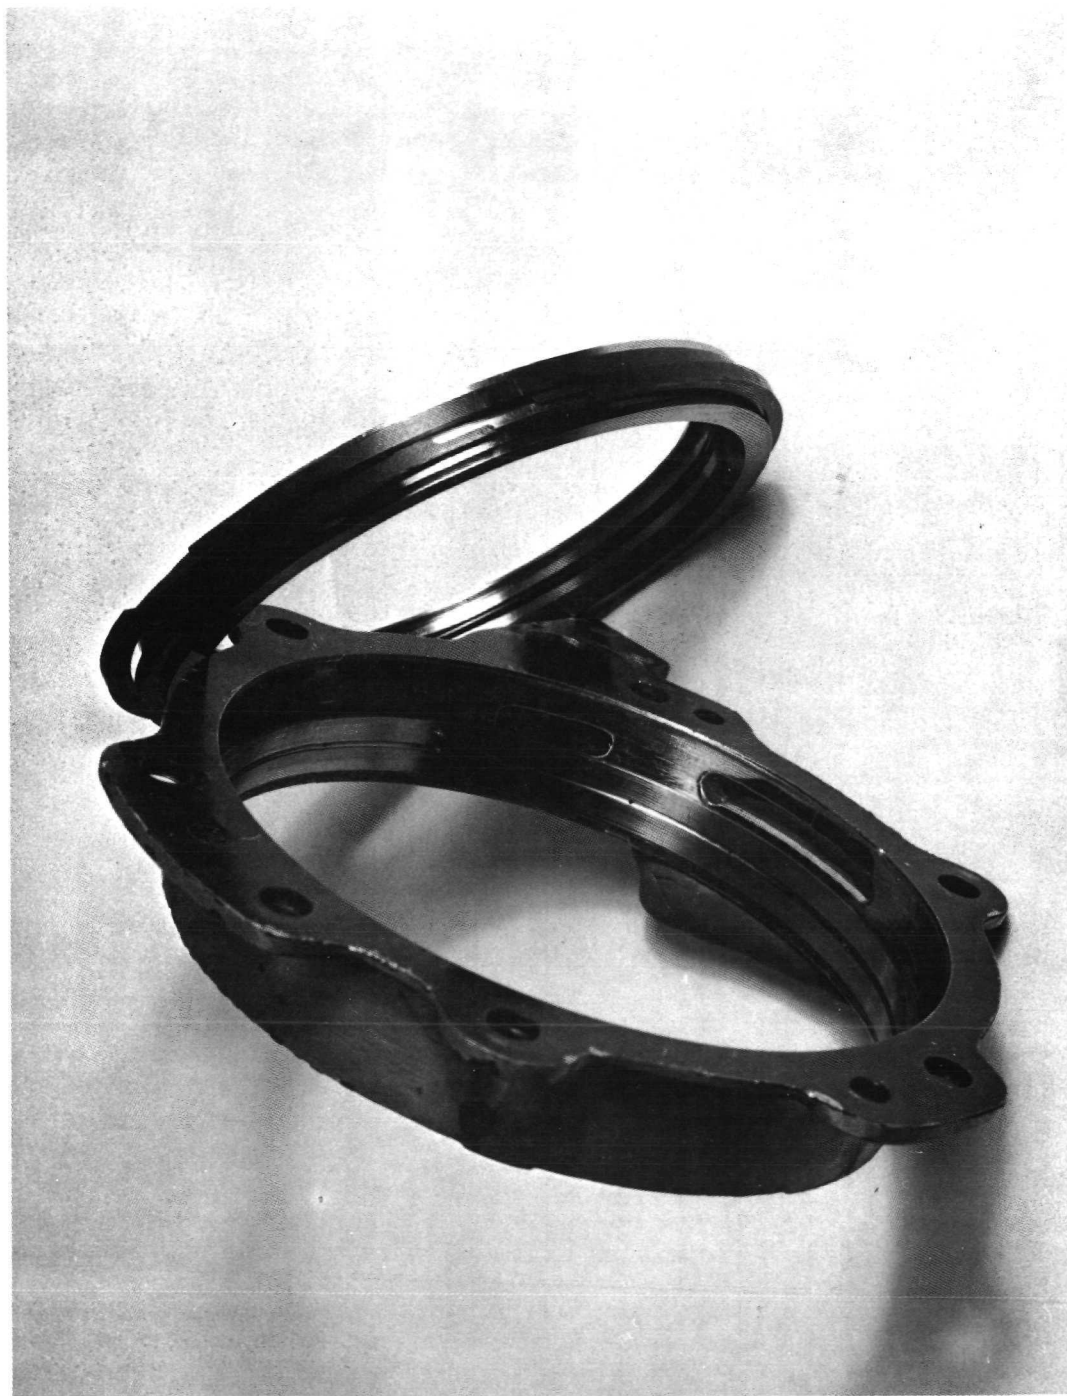
Figure 29. Modified Seal Housing with Rectangular Slot.

- 5) The seal housing was further modified by machining a drainage slot 6.35 m.m. (.250 inch) wide by 54 m.m. (2.125 inch) long at the bottom of the seal housing as shown in Figure 29. An aluminum manifold was bonded to the outside diameter of the seal case and connected to the reservoir. Increased drainage capacity was established with this approach. The leakage rate recorded was 65 c.c./hour which was still unsatisfactory.

This configuration was also tested by reducing the flow to the freewheel unit (Table 3) while the flow to the support bearings remained constant. Although leakage decreased, it was still unsatisfactory.

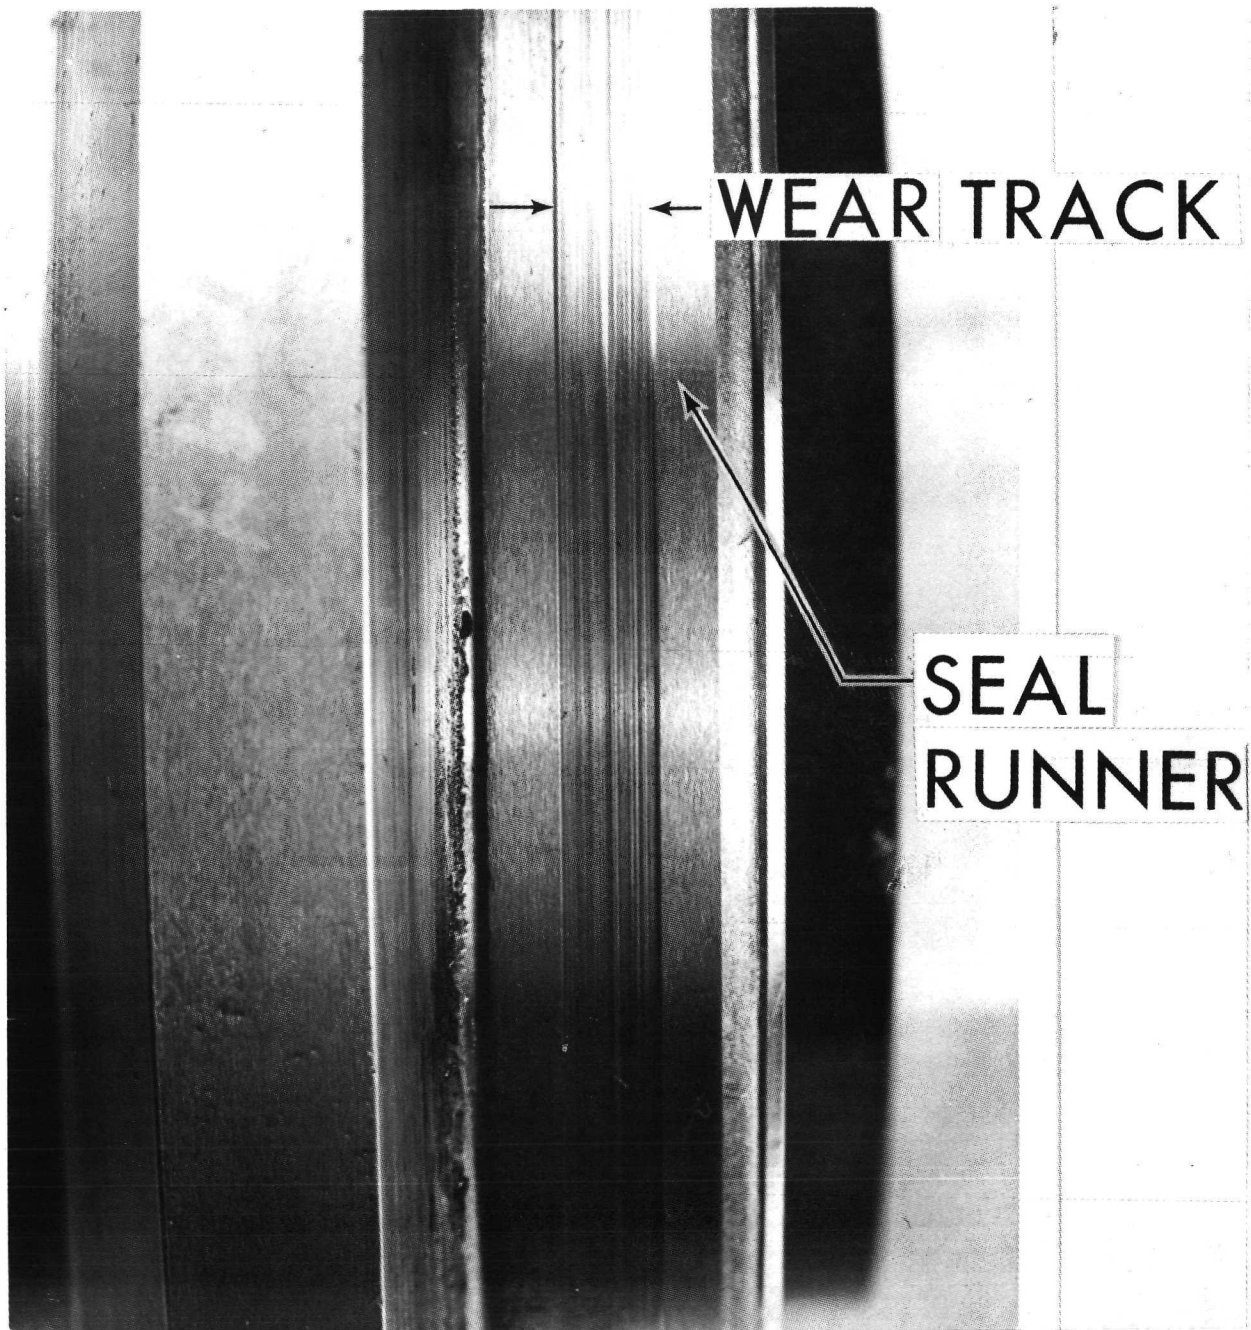
Figure 37. Seal Runner from 40-Hour Environmental Test, View A.

A leakage rate of .124 c.c./hour was recorded for the first 24-hour period and .095 c.c./hr. for the final 16-hour period. Due to abrasive action of the silica flour a wear groove was produced on the seal runner about .071 m.m. (.0028 inches) during the 40 hour test. Considering the severity of the test this was considered satisfactory performance, especially since the leakage actually decreased during the run. The carbon-graphite rings wear was approximately .0305 mm (.0012 inches). The profile trace of the seal runner is shown in Figure 35. Figure 36 and 37 shows the seal and the seal runner respectively.
